LOS ANGELES COUNTY JAIL PLAN

**APPENDIX G
-STUDY-
ONYX ARCHITECTS, DETENTION FACILITY
ASSESSMENT FOR MIRA LOMA DETENTION FACILITY**

LOS ANGELES COUNTY | DETENTION FACILITY ASSESSMENTS
MIRA LOMA DETENTION FACILITY

FEBRUARY 11TH, 2013

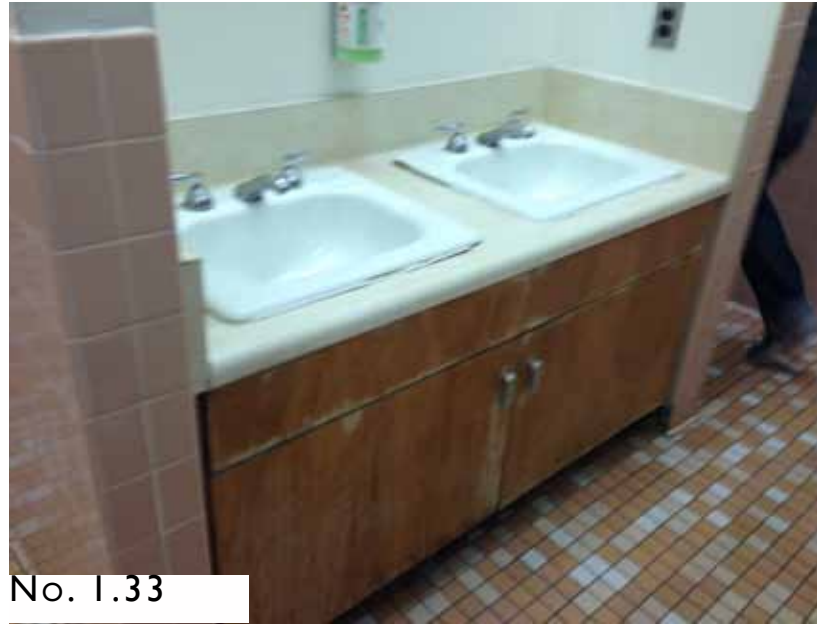
No. I.33

2	Structural															
3	Mechanical									■		■		1.66	EXISTING OLD ROOFTOP UNITS NEED TO BE REPLACED.	
4	Plumbing									■		■		1.33 1.41	PLUMBING FIXTURES NEED TO BE REPLACED.	
5	Electrical				■							■	■	1.59 1.60	Provide GFI at sink. May benefit from upgraded lighting (LED) or lighting controls.	
6	Other (If Applicable)

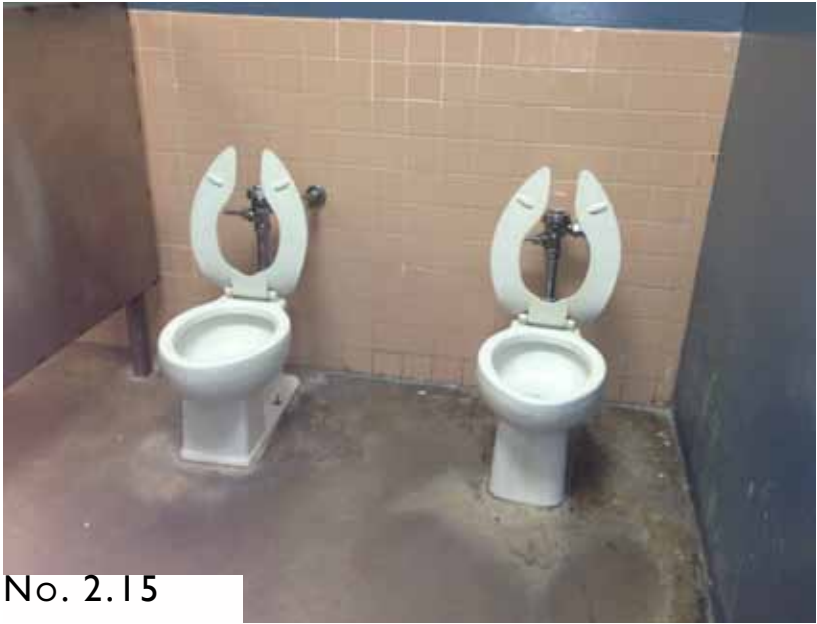
No. 2.15

2	Structural									■					Investigate further: CMU demising wall anchorage	
3	Mechanical									■		■		2.62	EXISTING OLD ROOFTOP UNITS NEED TO BE REPLACED.	
4	Plumbing									■		■		2.15 2.16	PLUMBING FIXTURES NEED TO BE REPLACED.	
5	Electrical				■							■	■	2.39	Provide GFI at sink. May benefit from upgraded lighting (LED) or lighting controls.	
6	Other (If Applicable)

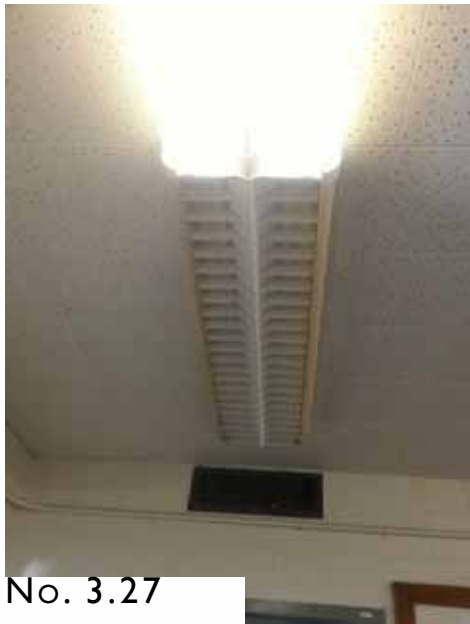
No. 3.27

2	Structural									■					Investigate further: CMU demising wall anchorage	
3	Mechanical									■		■			EXISTING OLD ROOFTOP UNITS NEED TO BE REPLACED.	
4	Plumbing									■		■			PLUMBING FIXTURES NEED TO BE REPLACED.	
5	Electrical				■					■		■	■	3.27	May benefit from upgraded lighting (LED) or lighting controls.	
6	Other (If Applicable)

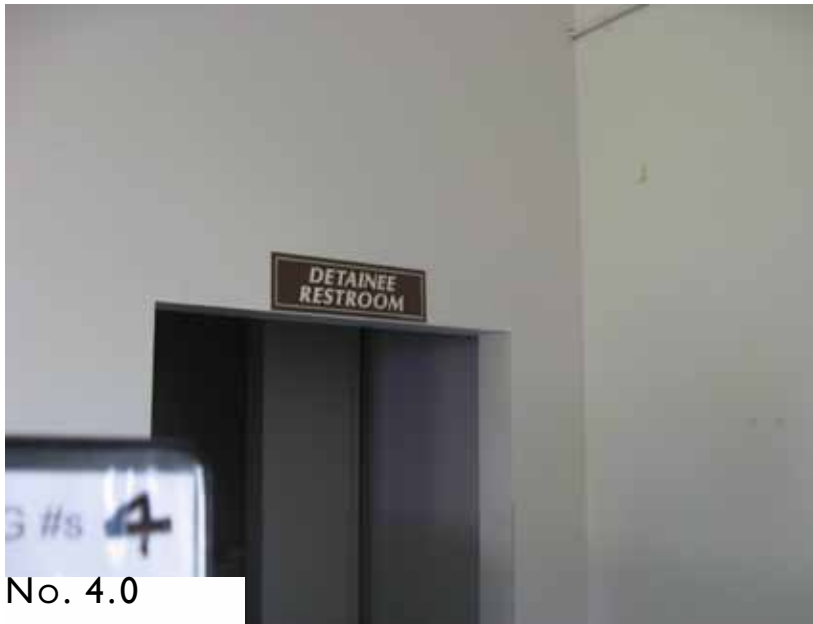
No. 4.0

2	Structural									■					Investigate further: CMU demising wall anchorage	
3	Mechanical									■		■		4.61	EXISTING OLD ROOFTOP UNITS NEED TO BE REPLACED.	
4	Plumbing									■		■		4.47	PLUMBING FIXTURES NEED TO BE REPLACED.	
5	Electrical				■							■	■	4.46	May benefit from upgraded lighting (LED) or lighting controls.	
6	Other (If Applicable)

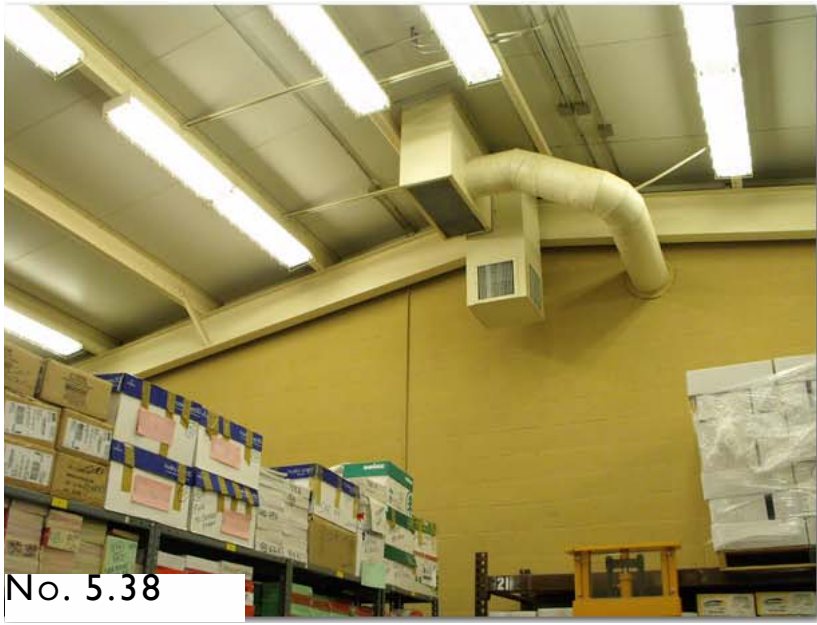
No. 5.38

2	Structural									■					Investigate further: CMU demising wall anchorage	
3	Mechanical									■		■		5.38	EXISTING OLD ROOFTOP UNITS NEED TO BE REPLACED.	
4	Plumbing									■		■		5.57	PLUMBING FIXTURES NEED TO BE REPLACED.	
5	Electrical				■									5.46	May benefit from upgraded lighting (LED) or lighting controls.	
6	Other (If Applicable)

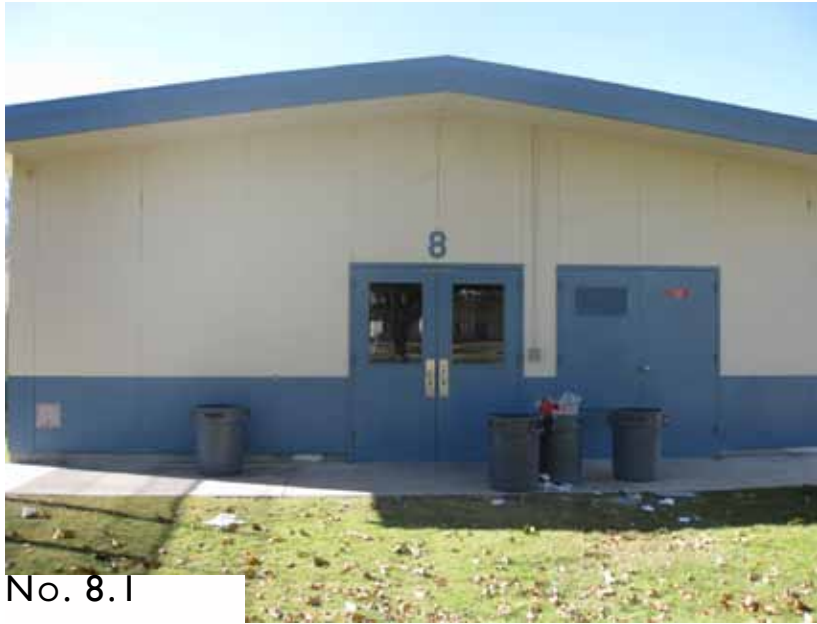
No. 8.3

2	Structural									■					Investigate further: CMU end wall anchorage	
3	Mechanical									■		■			DUCTWORKS NEED TO BE REROUTE PROPERLY FOR BETTER AIR DISTRIBUTION.	
4	Plumbing									■		■		8.3	PLUMBING FIXTURES NEED TO BE REPLACED.	
5	Electrical				■							■	■		May benefit from upgraded lighting (LED) or lighting controls.	
6	Other (If Applicable)

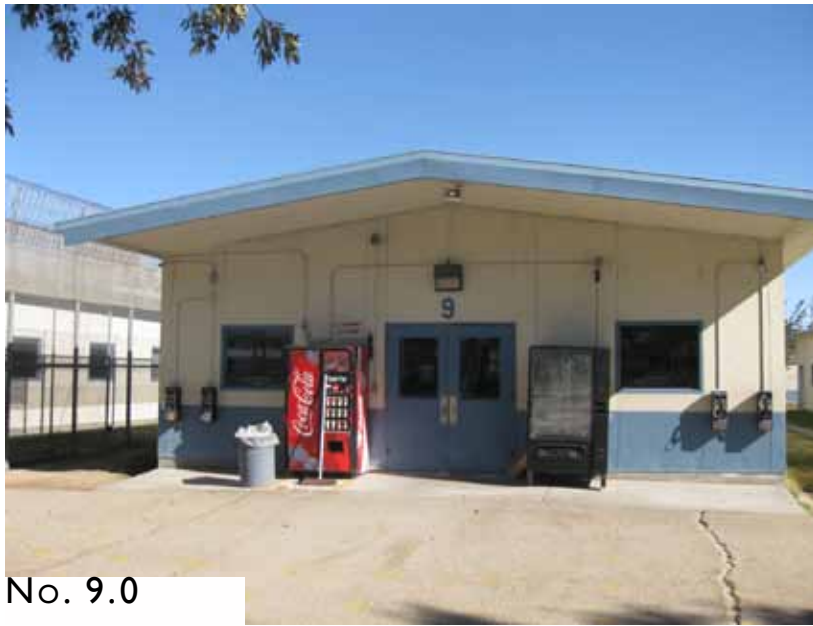
No. 9.0

2	Structural									■					Investigate further: CMU end wall anchorage	
3	Mechanical									■		■			DUCTWORKS NEED TO BE REROUTE PROPERLY FOR BETTER AIR DISTRIBUTION.	
4	Plumbing									■		■		9.3	PLUMBING FIXTURES NEED TO BE REPLACED.	
5	Electrical				■							■			May benefit from upgraded lighting (LED) or lighting controls.	
6	Other (If Applicable)

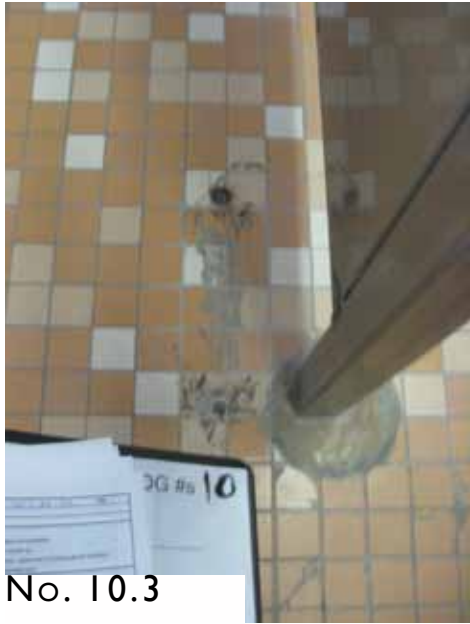
No. 10.7

2	Structural									■					Investigate further: CMU end wall anchorage	
3	Mechanical									■		■		10.7	DUCTWORKS NEED TO BE REROUTE PROPERLY FOR BETTER AIR DISTRIBUTION.	
4	Plumbing									■		■		10.9	PLUMBING FIXTURES NEED TO BE REPLACED.	
5	Electrical				■							■	■		May benefit from upgraded lighting (LED) or lighting controls.	
6	Other (If Applicable)

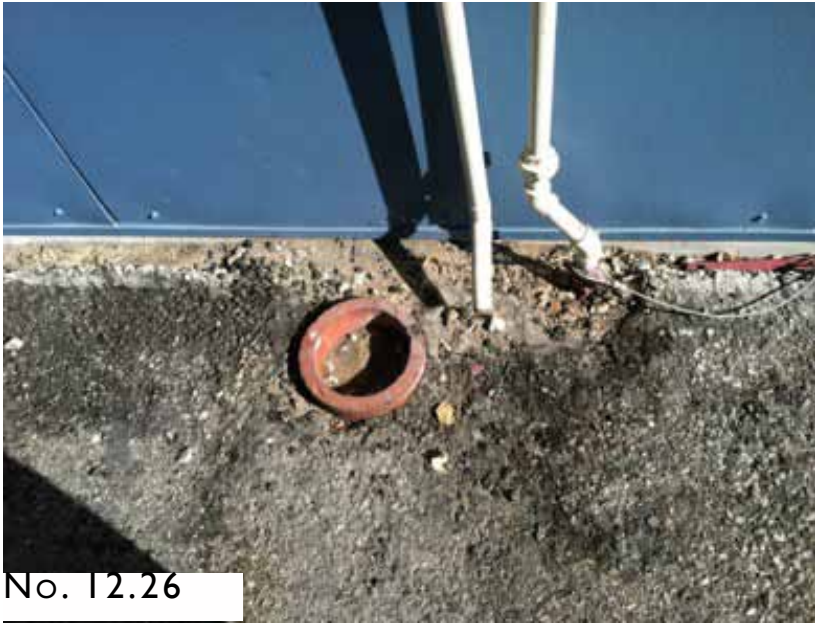
No. 12.26

2 Structural									■					Investigate further: CMU end wall anchorage		
	3 Mechanical									■		■			DUCTWORKS NEED TO BE REROUTE PROPERLY FOR BETTER AIR DISTRIBUTION.		
	4 Plumbing									■		■		12.26	PLUMBING FIXTURES NEED TO BE REPLACED.		
	5 Electrical				■							■	■		May benefit from upgraded lighting (LED) or lighting controls.		
	6 Other (If Applicable)

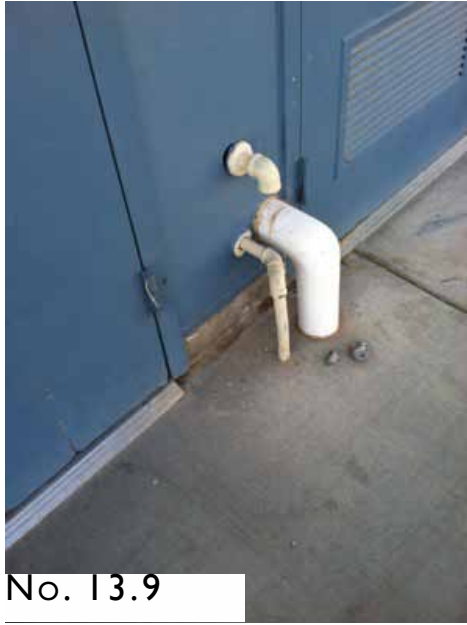
No. 13.9

2	Structural									■					Investigate further: CMU end wall anchorage		
3	Mechanical									■		■			DUCTWORKS NEED TO BE REROUTE PROPERLY FOR BETTER AIR DISTRIBUTION.		
4	Plumbing									■		■		13.9	PLUMBING FIXTURES NEED TO BE REPLACED.		
5	Electrical				■							■	■		May benefit from upgraded lighting (LED) or lighting controls.		
6	Other (If Applicable)

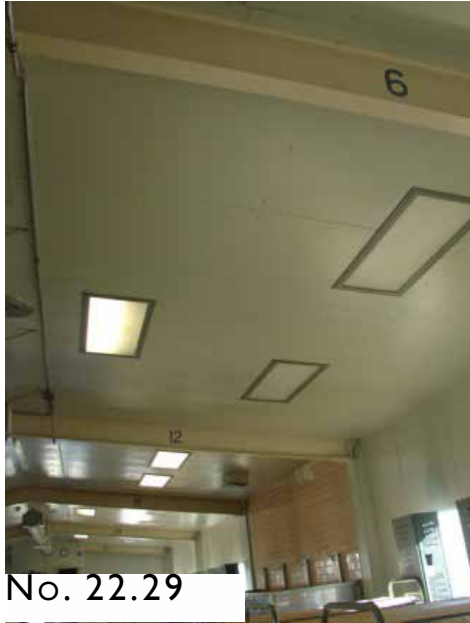
No. 22.29

2	Structural									■					Investigate further: CMU end wall anchorage	
3	Mechanical									■		■		22.49	DUCTWORKS NEED TO BE REROUTE PROPERLY FOR BETTER AIR DISTRIBUTION.	
4	Plumbing									■		■			PLUMBING FIXTURES NEED TO BE REPLACED.	
5	Electrical				■							■		22.29	May benefit from upgraded lighting (LED) or lighting controls.	
6	Other (If Applicable)

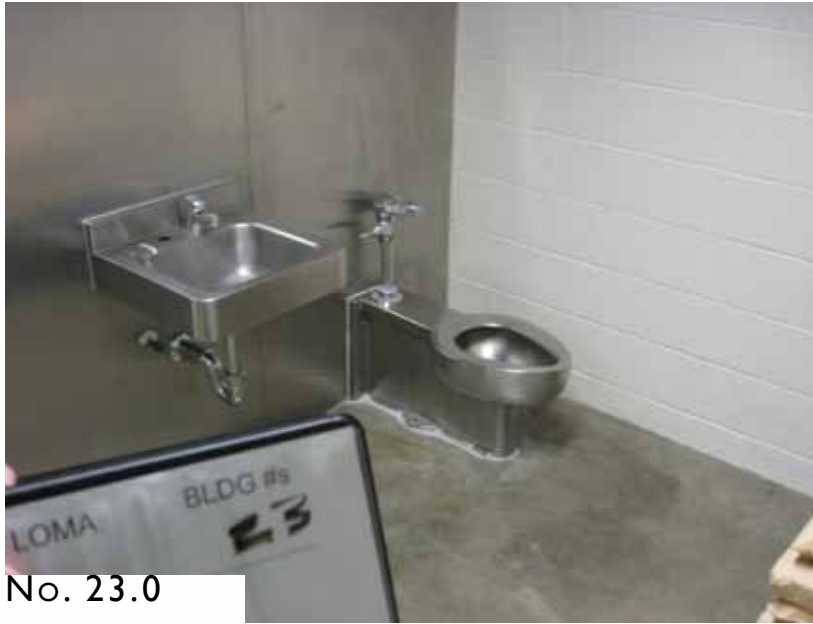
No. 23.0

1	Architectural				N	Y	16	2	32 +1:33	■				23.0, 1, 21, 22	C: needs accessible cell, toilet, staff toilet	
2	Structural															
3	Mechanical				■								■			
4	Plumbing				■								■	23.19		
5	Electrical				■							■	■	23.35	May benefit from upgraded lighting (LED) or lighting controls.	
6	Other (If Applicable)

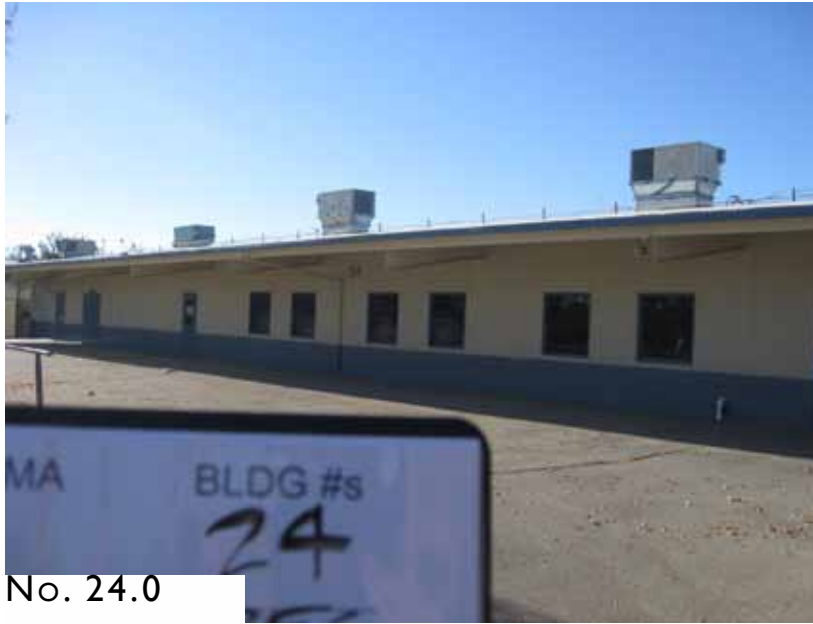
No. 24.0

Mira Loma Detention Facility										Bldg no. 24						
Building Condition (summary of all disciplines)										Bldg. name Recreation room						
Capacity (if applicable) Current Size / Count BSCC Standard Est Capacity / Rating										RATINGS						
										1 Code / Life Safety: required for basic occupancy and accessibility						
										2 Program: required to meet regulations for intended use						
										3 Maintenance: Repairs and routine maintenance / replacement to prolong useful life of building						
										4 Sustainability: recommendations to lower operating costs						
Discipline		Rating			Compliance		Program Capacity			Recommendation						
	Building Name / Use	Poor (Red)	Fair (Yllw)	Good (Grn)	Code, ADA	BSCC	Existing	Program Std.	Capacity	Code	Program	Maintenance	Sustainability	Photo Ref.	Comments	OPC
	OVERALL															
1	Architectural				N					■		■		24.0, 5, 7, 21, 40	C: ADA toilet handrail + pipe insulation, move toilet partition 1"; M: pinched downspout

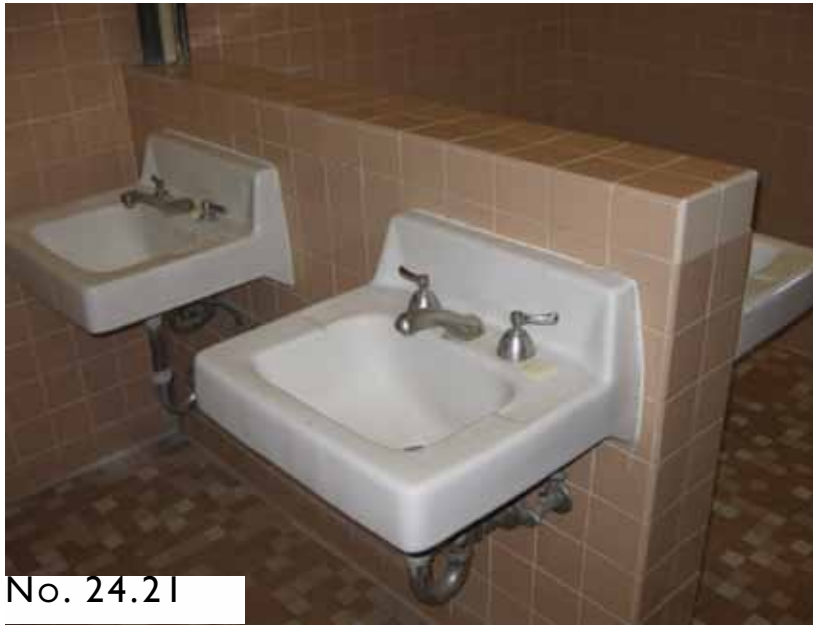
No. 24.21

2	Structural									■					Investigate further: CMU end wall anchorage	
3	Mechanical									■		■		24.47	DUCTWORKS NEED TO BE REROUTE PROPERLY FOR BETTER AIR DISTRIBUTION.	
4	Plumbing						4T, 4S			■		■		24.21 24.23	PLUMBING FIXTURES NEED TO BE REPLACED.	
5	Electrical				■							■	■	24.45	May benefit from upgraded lighting (LED) or lighting controls.	
6	Other (If Applicable)

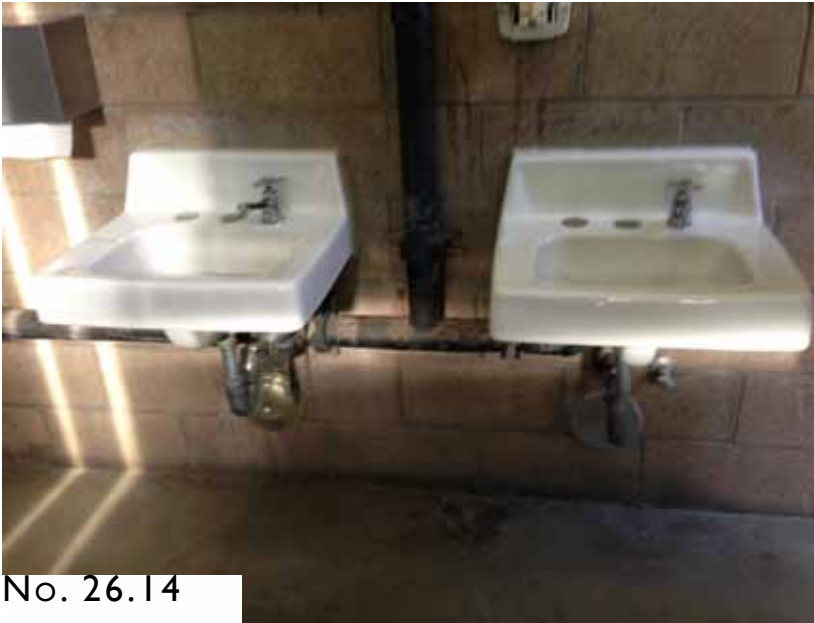
No. 26.14

2	Structural															
3	Mechanical									■		■			NO PROPER VENTILATION.	
4	Plumbing									■		■		26.14	PLUMBING FIXTURES NEED TO BE REPLACED.	
5	Electrical				■							■	■			
6	Other (If Applicable)

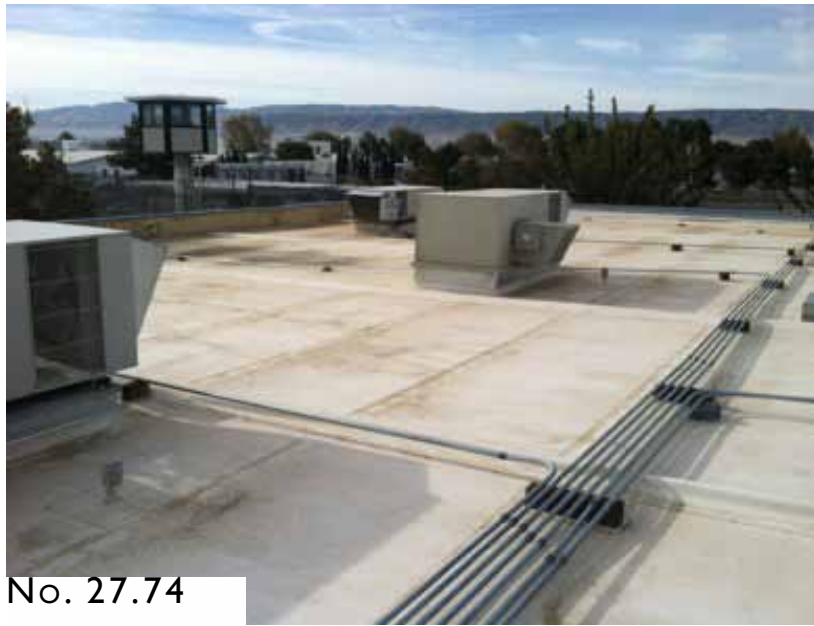
No. 27.74

2 Structural															
	3 Mechanical				■	■							■	27.74	EXISTING OLD ROOFTOP UNITS NEED TO BE REPLACED.	
	4 Plumbing				■	■							■		PLUMBING FIXTURES NEED TO BE REPLACED.	
	5 Electrical				■							■	■	27.32	May benefit from upgraded lighting (LED) or lighting controls.	
	6 Other (If Applicable)

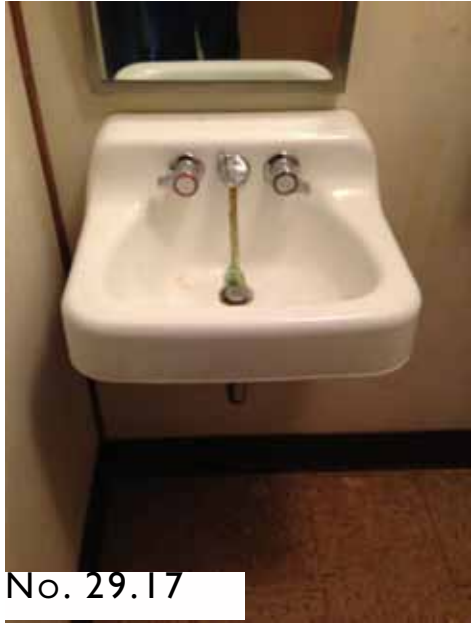
No. 29.17

2 Structural															
	3 Mechanical									■		■			EXISTING OLD ROOFTOP UNITS NEED TO BE REPLACED.	
	4 Plumbing									■		■		29.17	PLUMBING FIXTURES NEED TO BE REPLACED.	
	5 Electrical				■									29.21	May benefit from upgraded lighting (LED) or lighting controls.	
	6 Other (If Applicable)

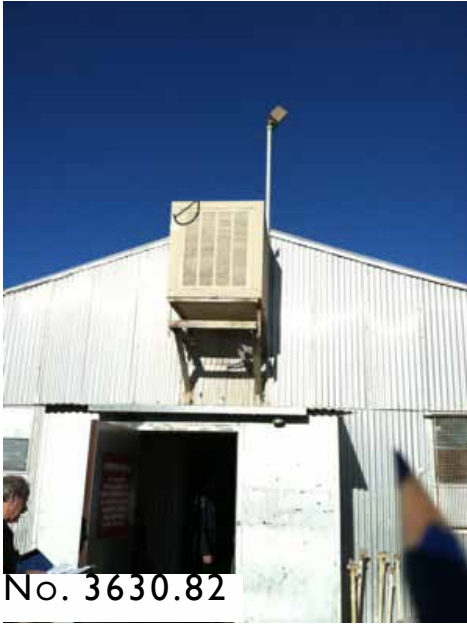
No. 3630.82

2	Structural									■					Retrofit: URM walls without anchorage, diagonal sheathing, clerestory, insufficient rod bracing, etc.	
3	Mechanical									■		■		3630.82 3630.85	ALL EXISTING EVAPORATIVE COOLERS (ABANDONED) NEED TO BE REMOVED AND EXHAUST FANS NEED TO BE REPLACED.	
4	Plumbing									■		■			PLUMBING FIXTURES NEED TO BE REPLACED.	
5	Electrical										■	■	■			
6	Other (If Applicable)

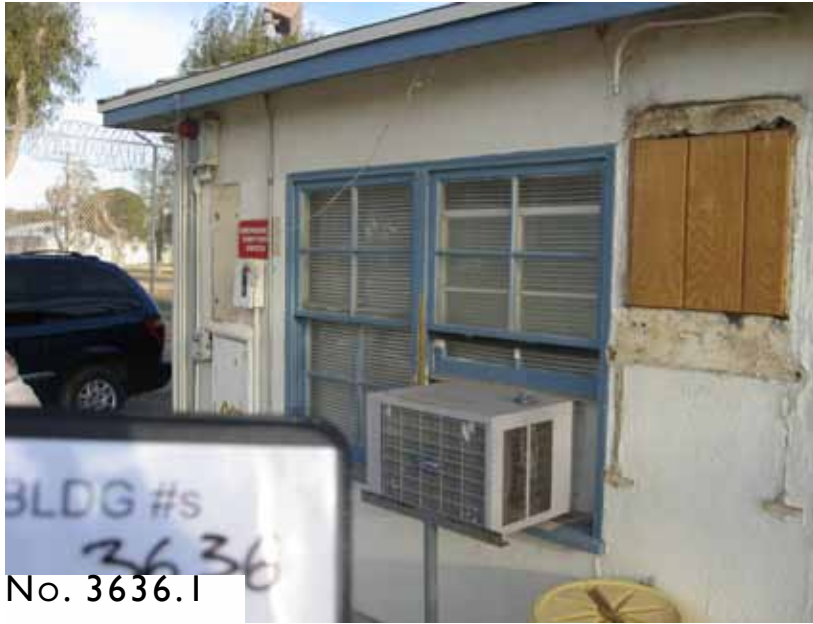
No. 3636.1

2	Structural															
3	Mechanical									■		■		3636.1	ALL EXISTING EVAPORATIVE COOLERS (ABANDONED) NEED TO REMOVED.	
4	Plumbing									■		■				
5	Electrical										■	■	■	3636.1	May benefit from upgraded lighting (LED) or lighting controls.	
6	Other (If Applicable)

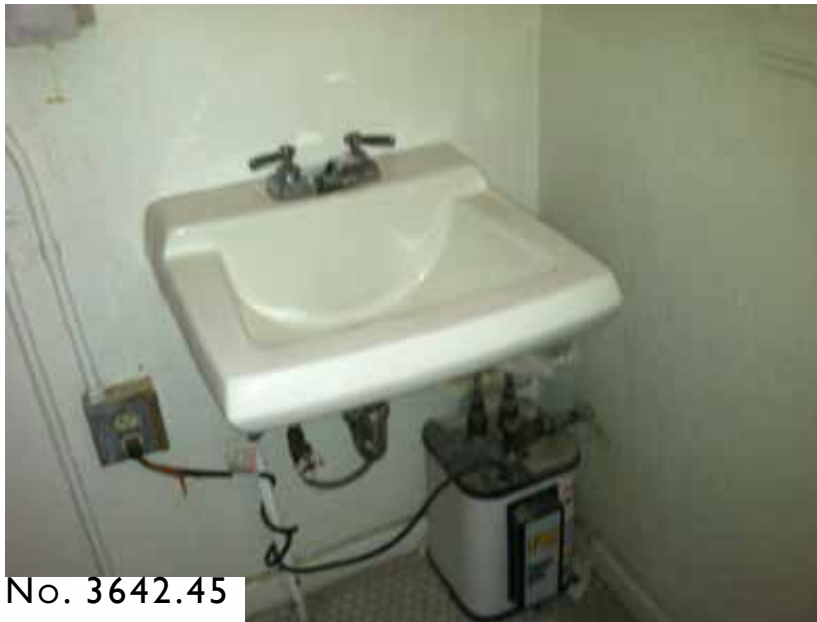
No. 3642.45

2 Structural															
	3 Mechanical													3642.56	ALL EXISTING EVAPORATIVE COOLERS (ABANDONED) NEED TO REMOVED.	
	4 Plumbing													3642.45	PLUMBING FIXTURES NEED TO BE REPLACED.	
	5 Electrical															
	6 Other (If Applicable)

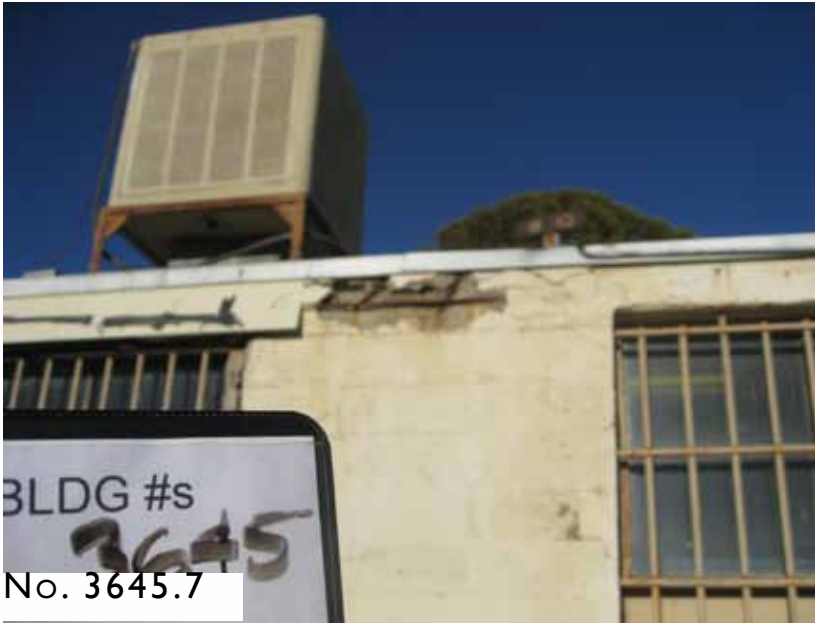
No. 3645.7

2	Structural															
3	Mechanical									■		■		3645.7	ALL EXISTING EVAPORATIVE COOLERS NEED TO BE REPLACED.	
4	Plumbing									■		■			PLUMBING FIXTURES NEED TO BE REPLACED.	
5	Electrical											■		3645.28	May benefit from upgraded lighting (LED) or lighting controls.	
6	Other (If Applicable)

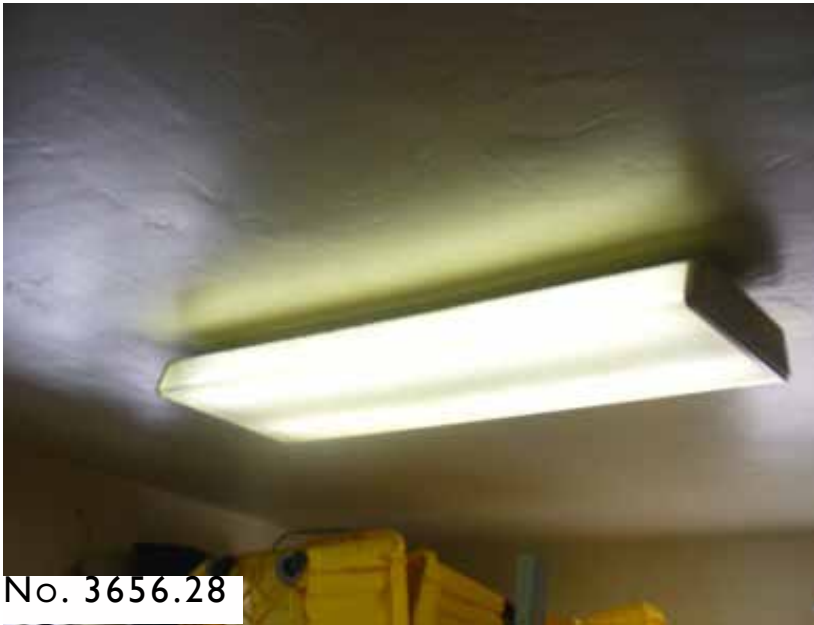
No. 3656.28

2	Structural															
3	Mechanical									■		■			ALL EXISTING EVAPORATIVE COOLERS NEED TO BE REPLACED.	
4	Plumbing									■		■		3656.18	PLUMBING FIXTURES NEED TO BE REPLACED.	
5	Electrical													3656.28	May benefit from upgraded lighting (LED) or lighting controls.	
6	Other (If Applicable)
